Technical Report REMR-CS-60
September 1998

Repair, Evaluation, Maintenance, and Rehabilitation Research Program

Performance Criteria for Concrete Repair Materials, Phase II Field Studies

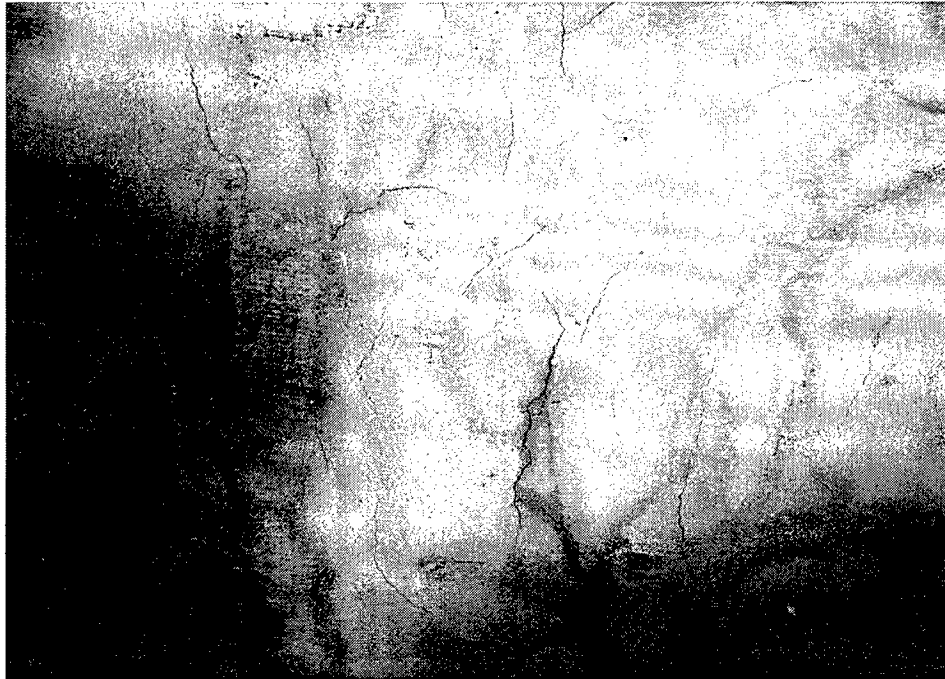
Figure 12. Severe cracking, Material No. 5 (Florida)

recommendations, the mixture was not extended with aggregate in the Florida tests. Despite immediate sprinkling with water after finishing, early age, plastic-shrinkage cracking occurred in each of the three repairs (Figure 12).

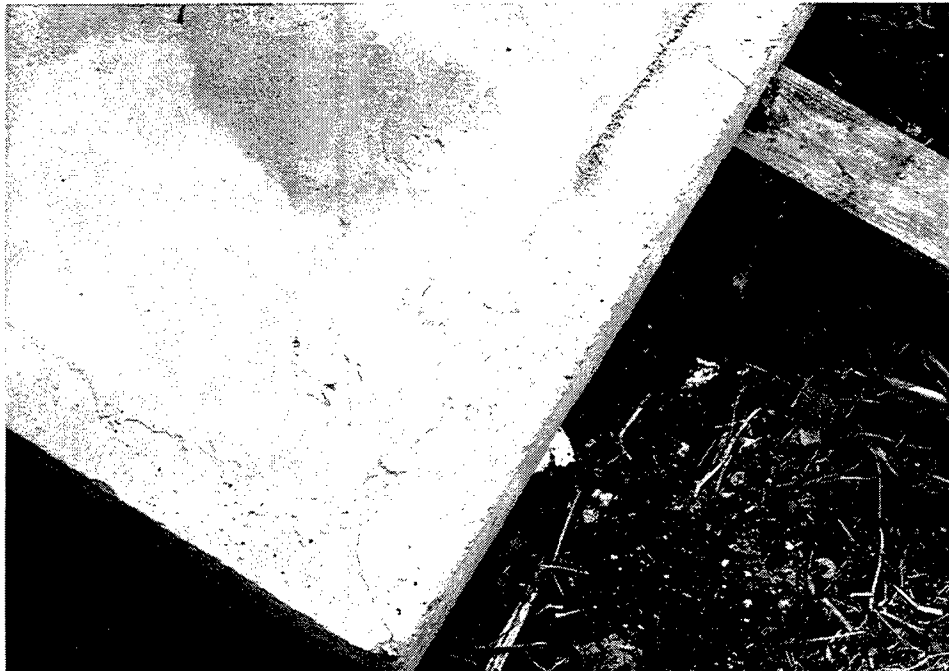
Figure 13. Cracks in the cavity walls, Material No. 5 (Florida)

The rapid setting of Material No. 5 was accompanied by a high heat of hydration. Expansion of the repair material associated with the high temperature rise was sufficient to cause cracking in the precast concrete cavity walls (Figure 13). Subsequent cooling and restrained contraction of the repair material may have contributed to the early age cracking observed. Consequently, the manufacturer recommended that the mixture be extended with coarse aggregate for the remaining tests. Early age cracking in Repair 6C was also attributed to plastic shrinkage.

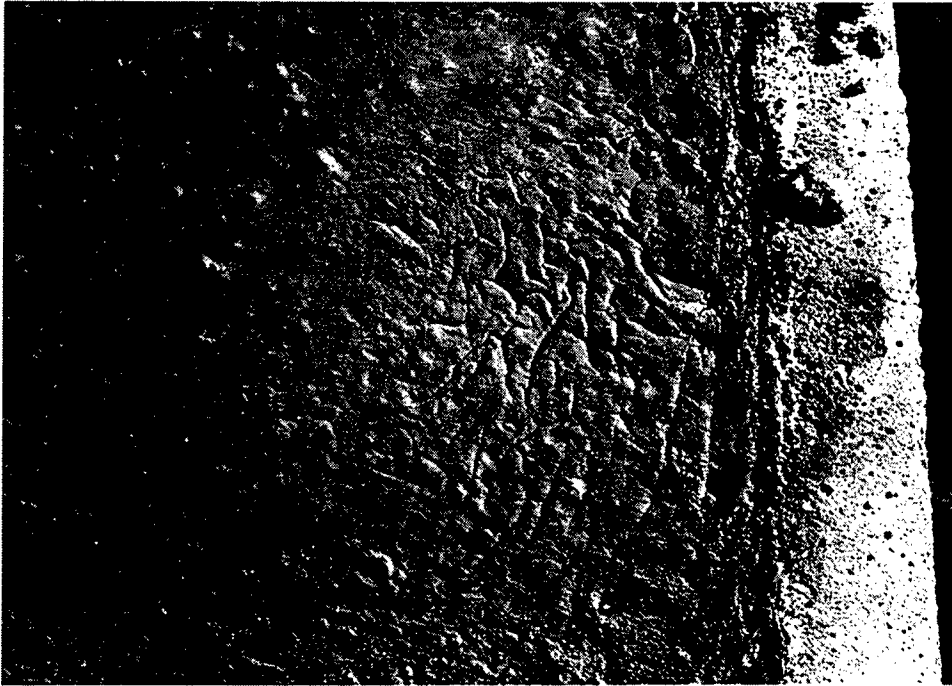
Figure 14. Very cohesive material (No. 10), sticky, difficult to finish (Florida)

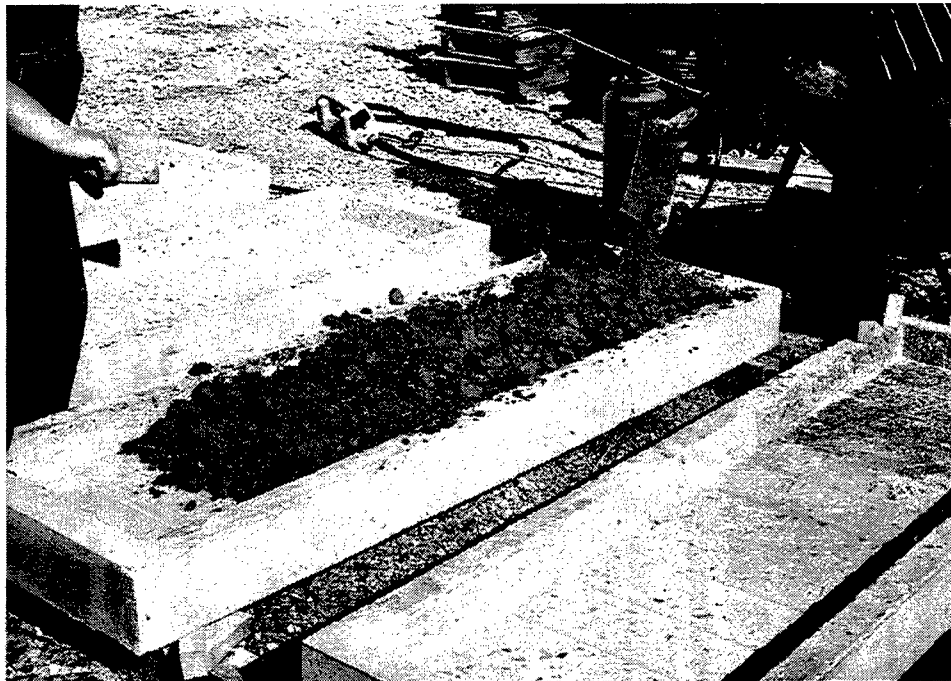
Figure 16. Example of a material (No. 8) that was very difficult to place and finish (Illinois)

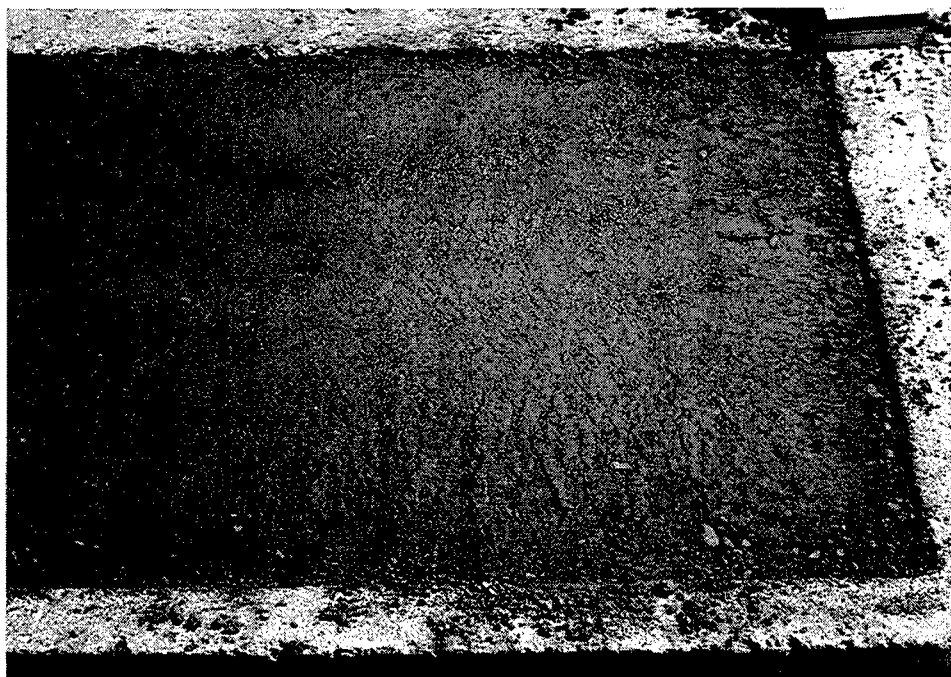
Figure 17. Material (No. 12) that was not easy to finish (Illinois)

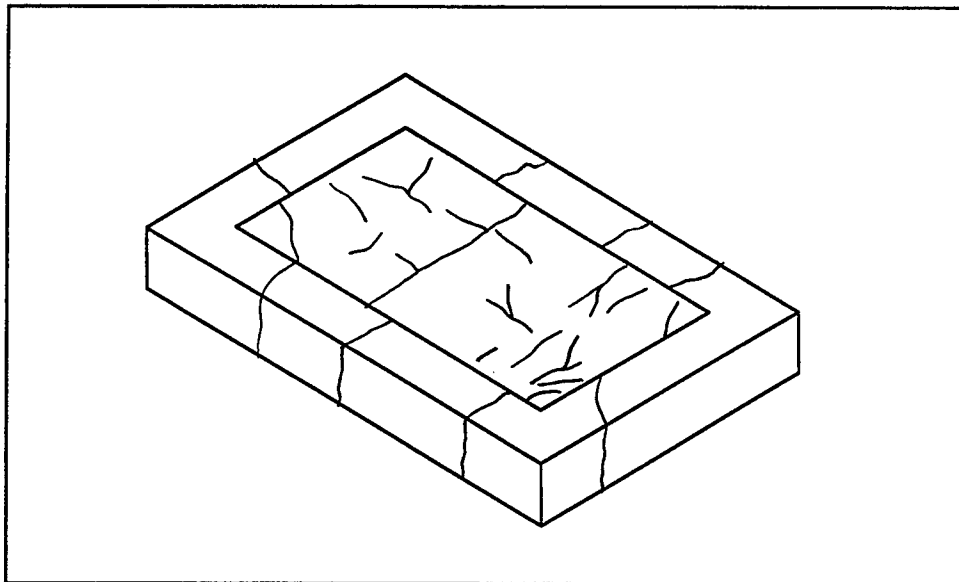
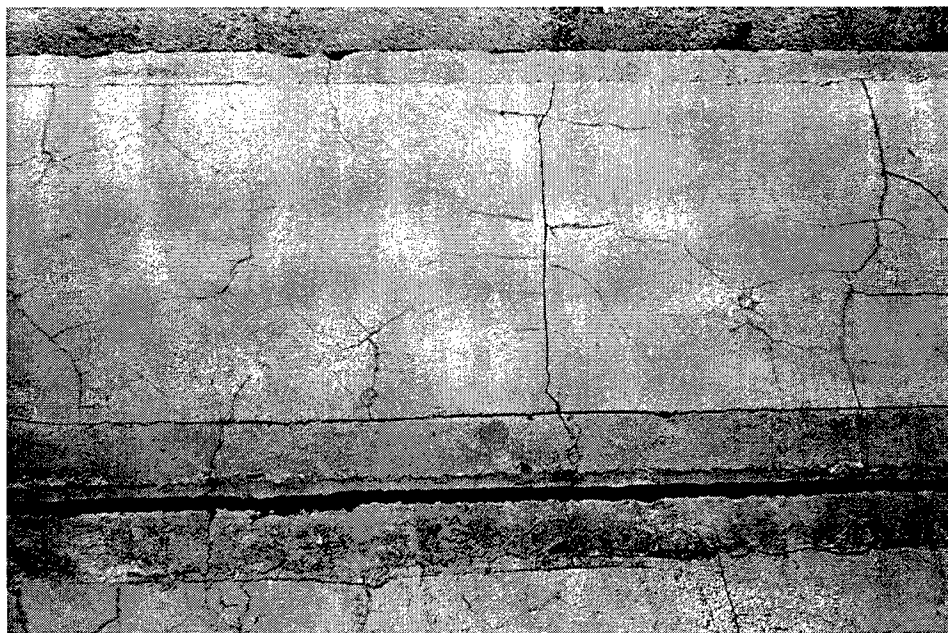
Figure 29. Cracking of Material No. 5A (Florida)

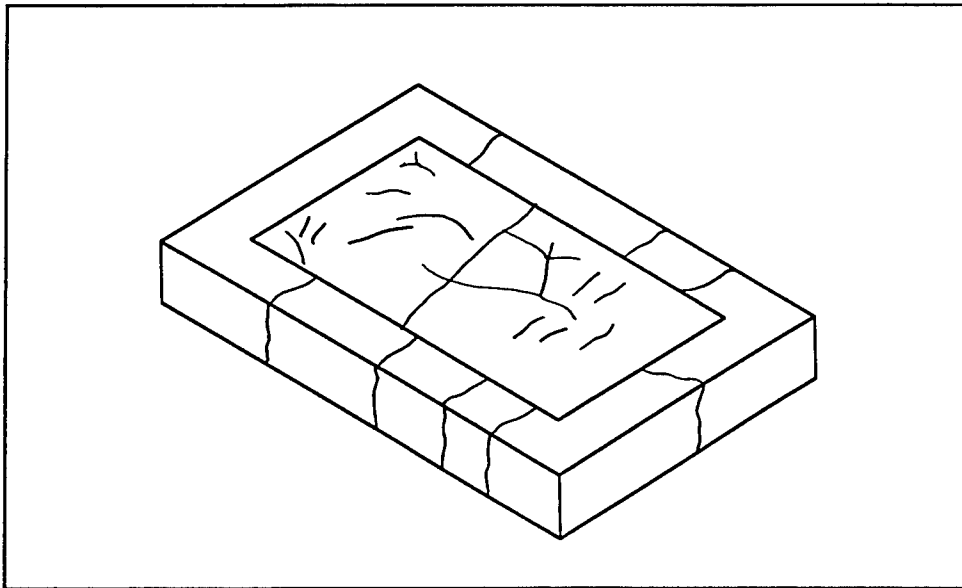
Figure 30. Cracking of Material No. 5B (Florida)

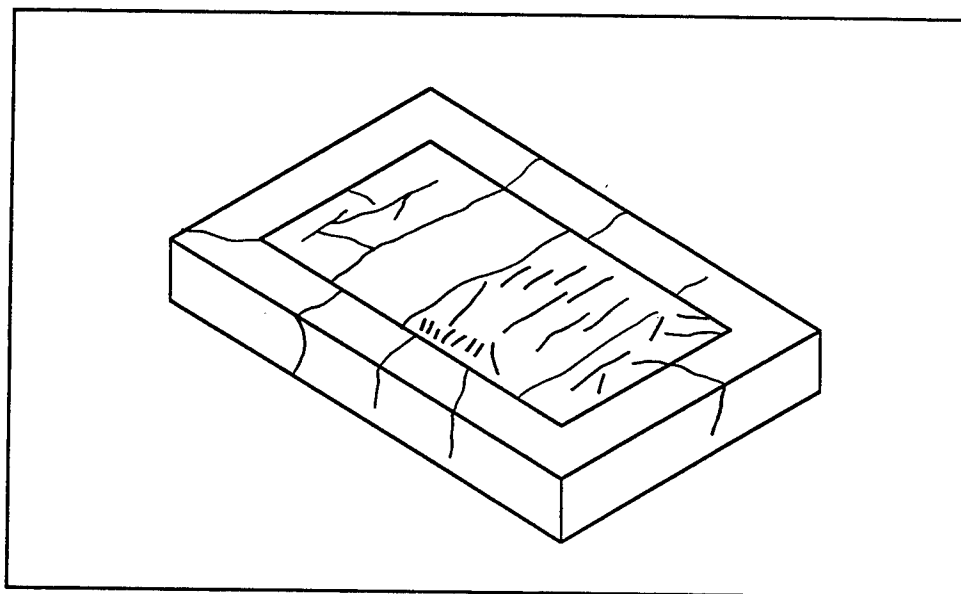
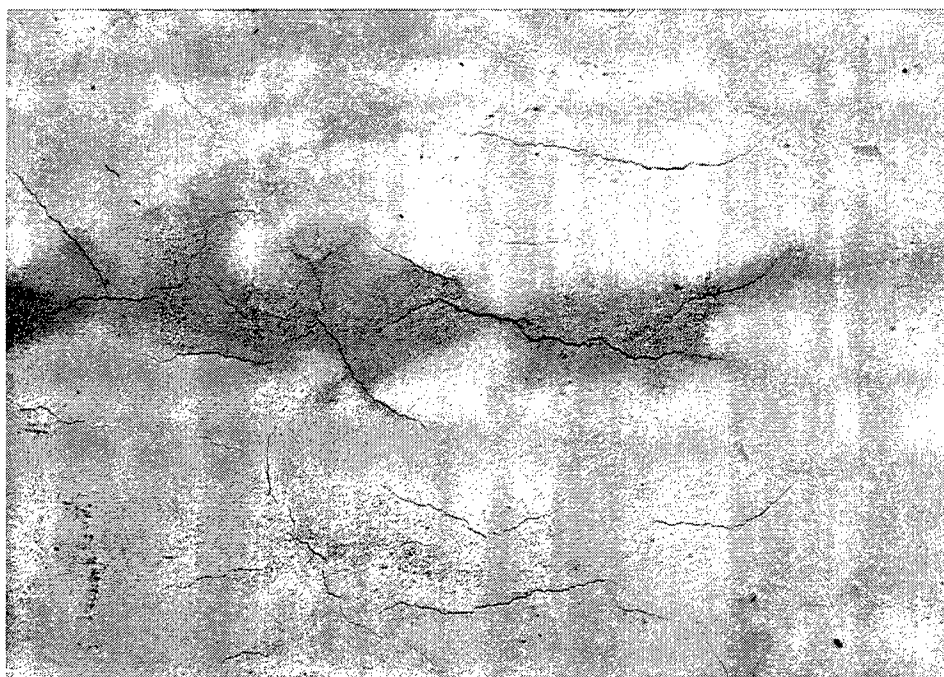
Figure 31. Cracking of Material No. 5C (Florida)

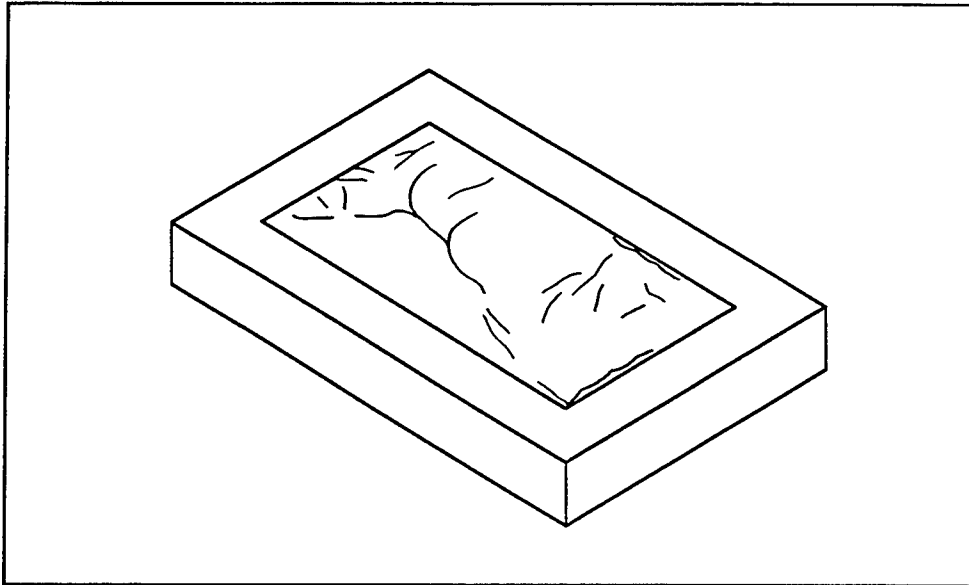
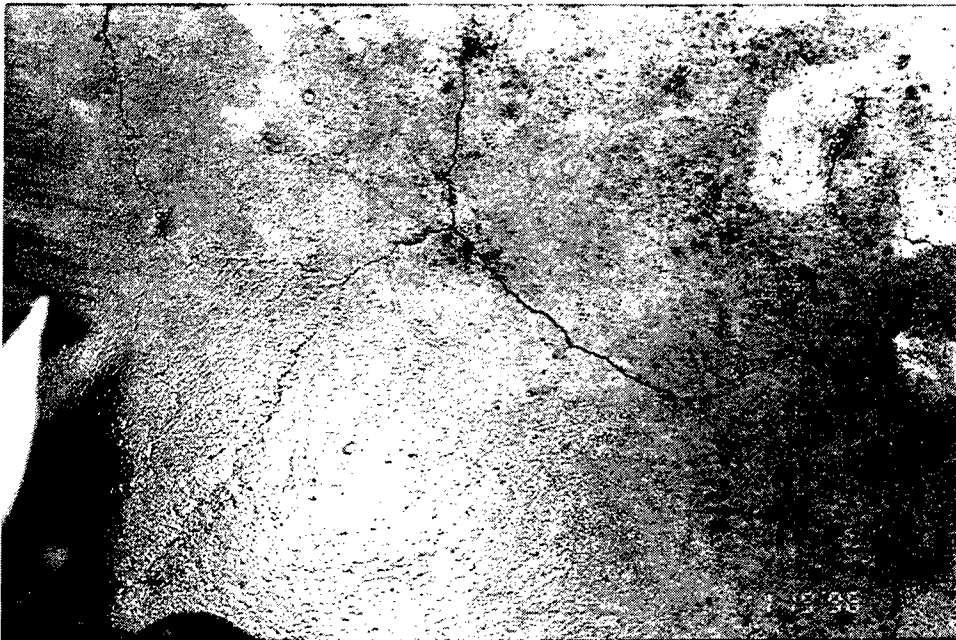
Figure 32. Cracking of Material No. 6C (Florida)

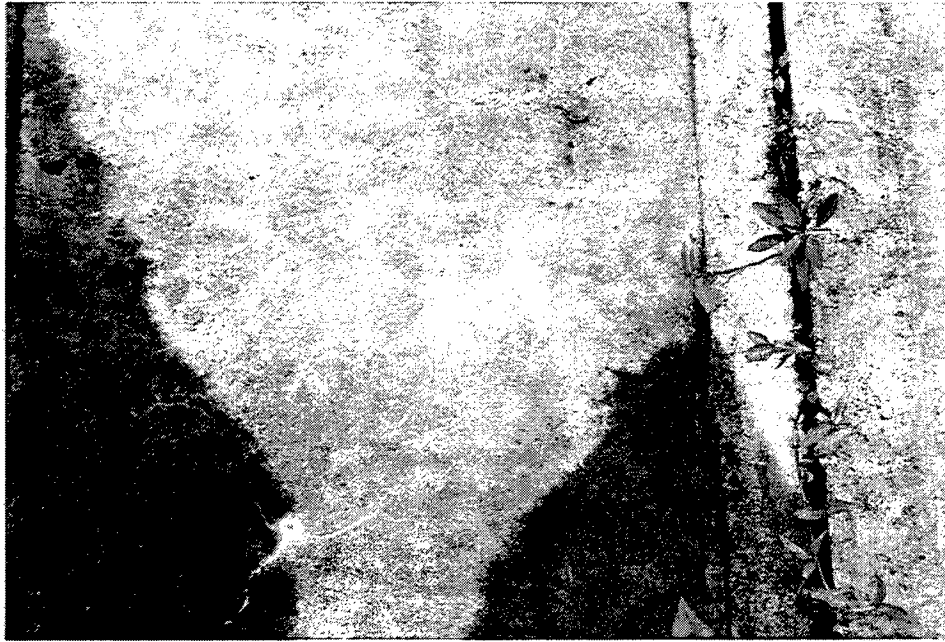
8	08/01/94	Fine surface crazing.	Fine surface crazing.	Fine surface crazing. Figure 33.
9	08/19/94	Minor surface crazing.	No cracks.	No cracks.
10	08/03/94	Very fine surface crazing in repair and cracking in precast form noted at 260 days.	Very fine surface crazing in repair and cracking in precast form noted at 260 days.	Very fine surface crazing in repair and cracking in precast form noted at 260 days.
11	08/04/94	No cracks.	No cracks.	No cracks.
12	08/05/94	No cracks.	No cracks.	No cracks.

Figure 33. Surface crazing of Material No. 8 (Florida)

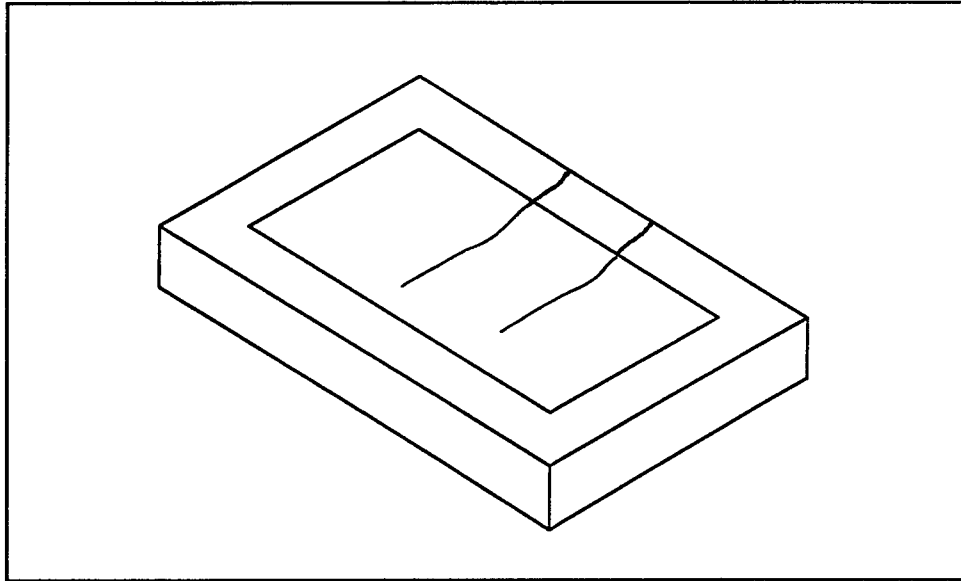
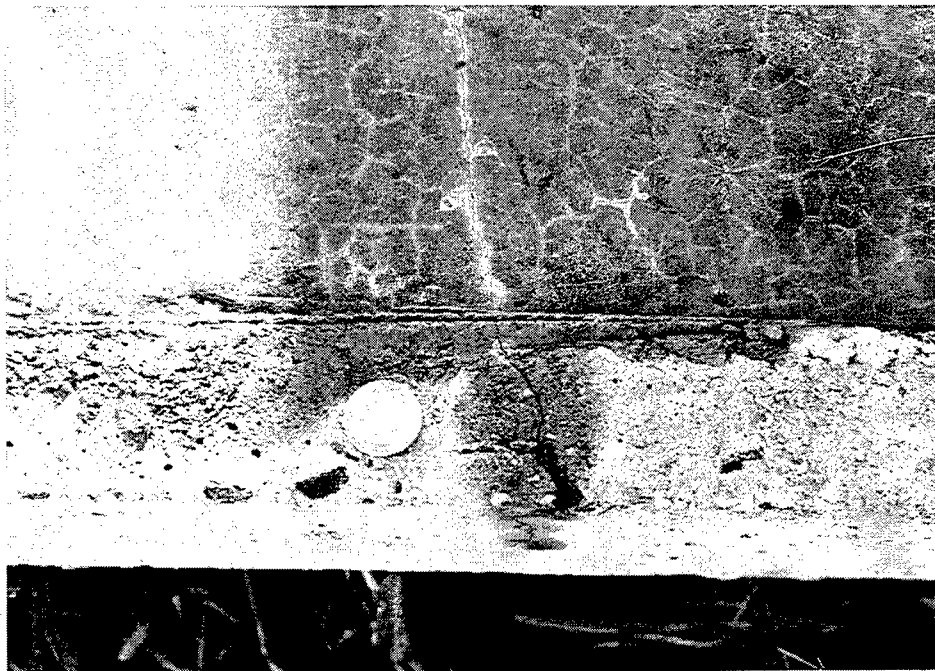
Figure 34. Cracking of Material No. 5C (Illinois)

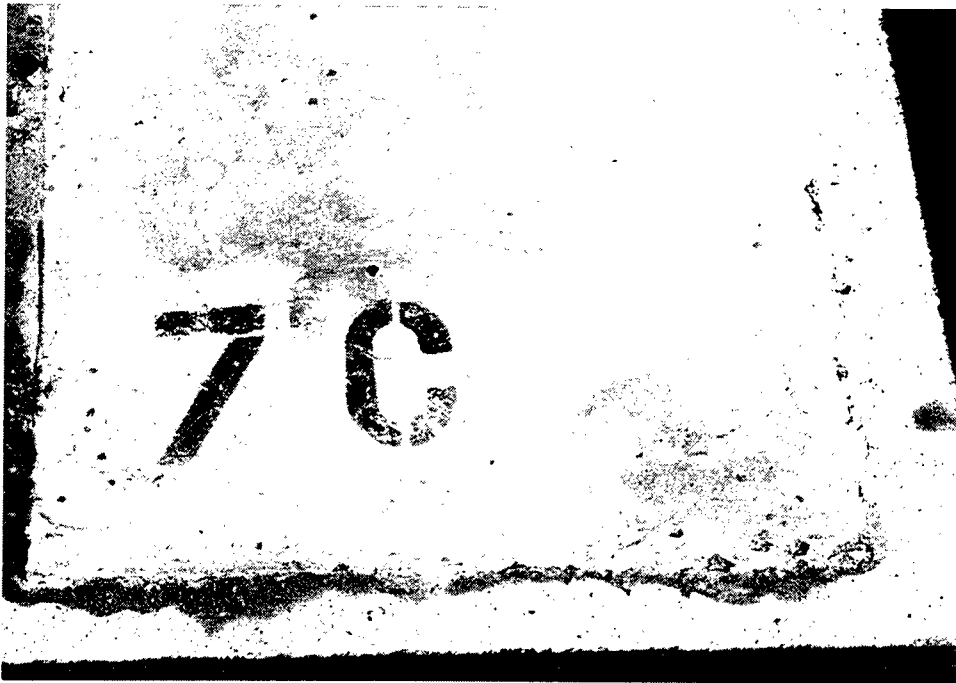
Figure 35. Surface crazing of Material No. 7C (Illinois)

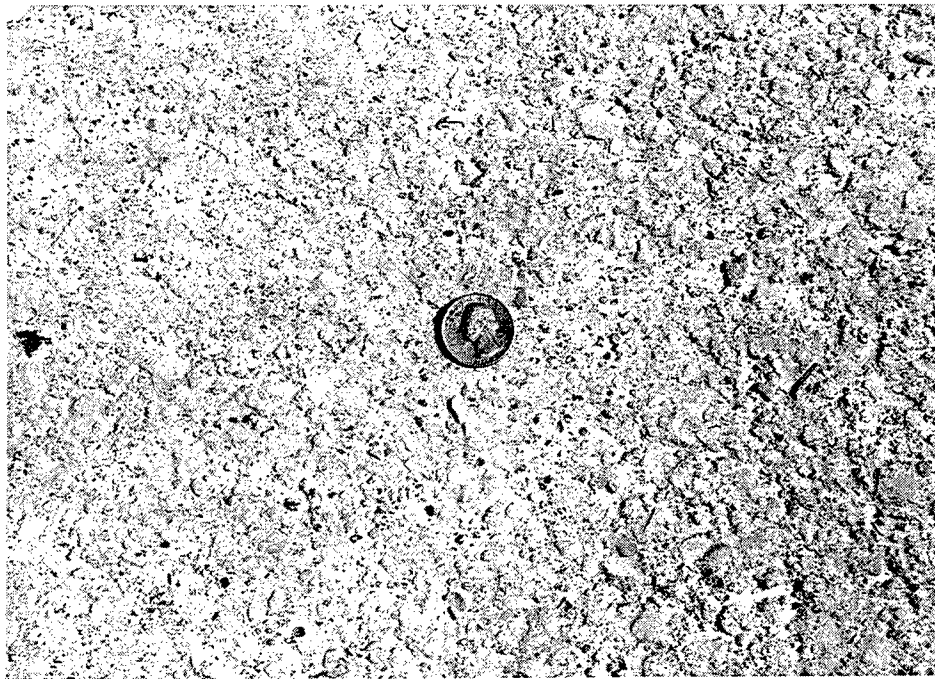
Figure 37. Surface deterioration of Material No. 12C (Illinois)

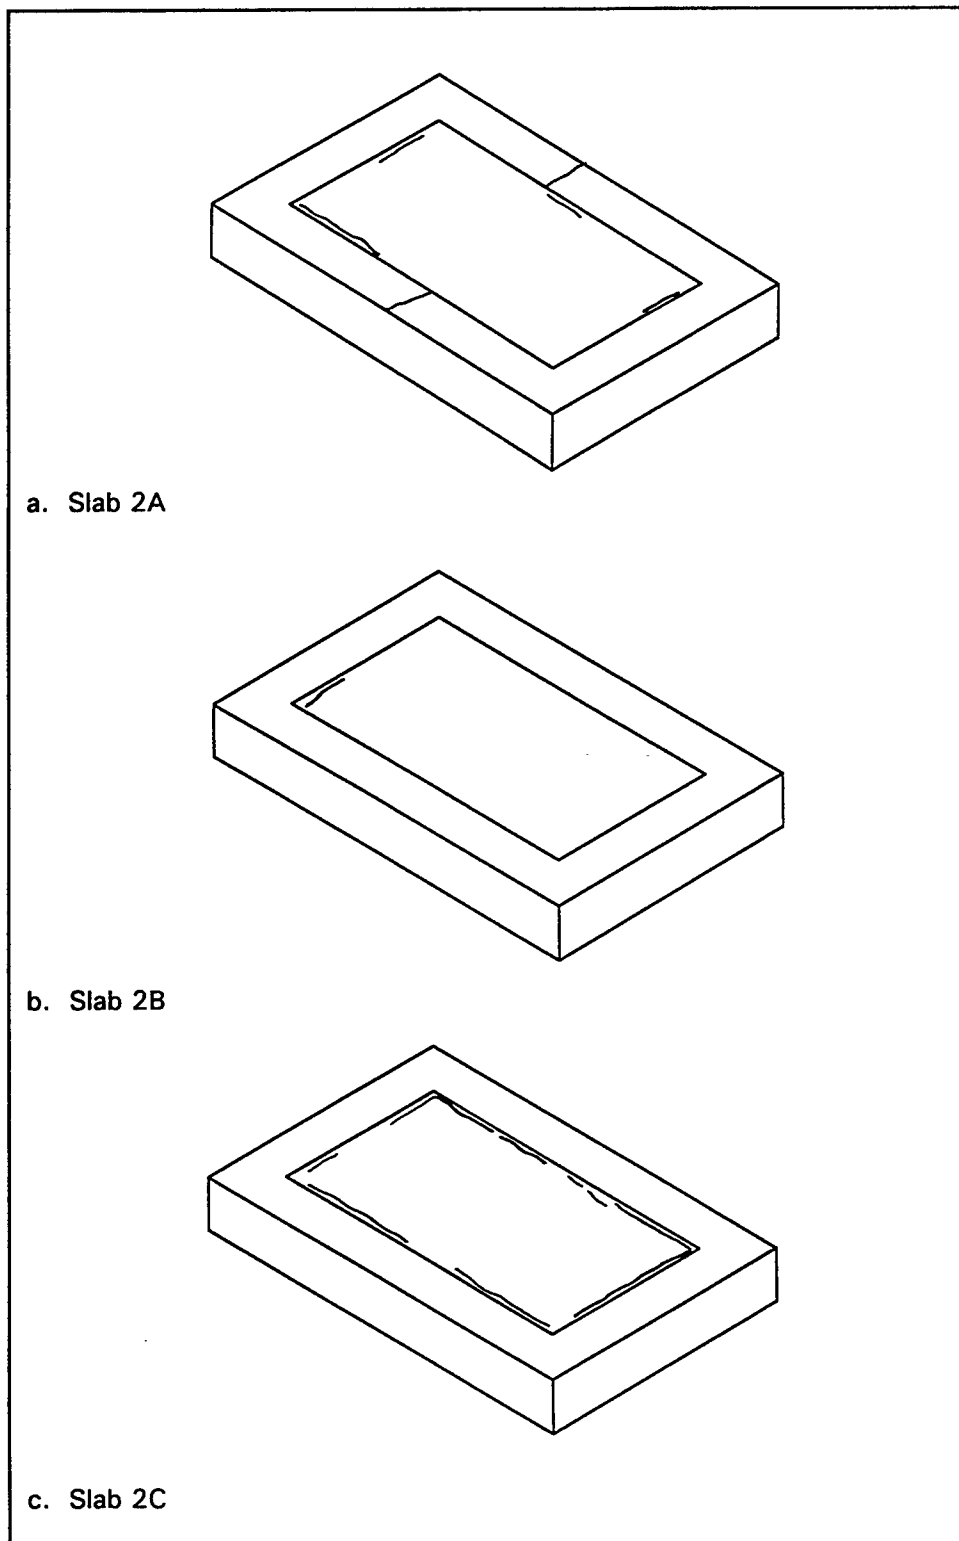
Material No.	Date of Placement	Observations		
		Repair A	Repair B	Repair C
1	12/06/94	No cracks.	No cracks.	No cracks.
2	12/07/94	Four edge cracks noted at 7 days. Figure 38.	One edge crack noted at 7 days.	Seven edge cracks noted at 7 days. Two additional cracks noted at 14 days. One additional crack noted at 28 days.
3	12/06/94	Surface checking noted at 200 days.	One transverse crack noted at 170 days. Figure 39.	Surface checking noted at 200 days.
4	12/07/94	No cracks.	No cracks.	No cracks.
5	12/08/94	No cracks.	One edge crack noted at 7 days. One transverse crack noted at 500 days. Figure 40.	One edge crack noted at 7 days.
6	12/06/94	One edge crack noted at 7 days. One transverse crack noted at 620 days. Figure 41a.	Six edge cracks noted at 7 days. Figure 41b.	Four edge cracks noted at 7 days. Figure 41c.
7	12/06/94	Not cast.	Surface checking noted at 7 days. Three short transverse cracks noted at 135 days. Figure 42.	Surface checking noted at 7 days age. One crack noted at 7 days. Ten additional cracks noted 135 days. Figure 42.

Figure 38. Edge cracking associated with Material No. 2 (Arizona)

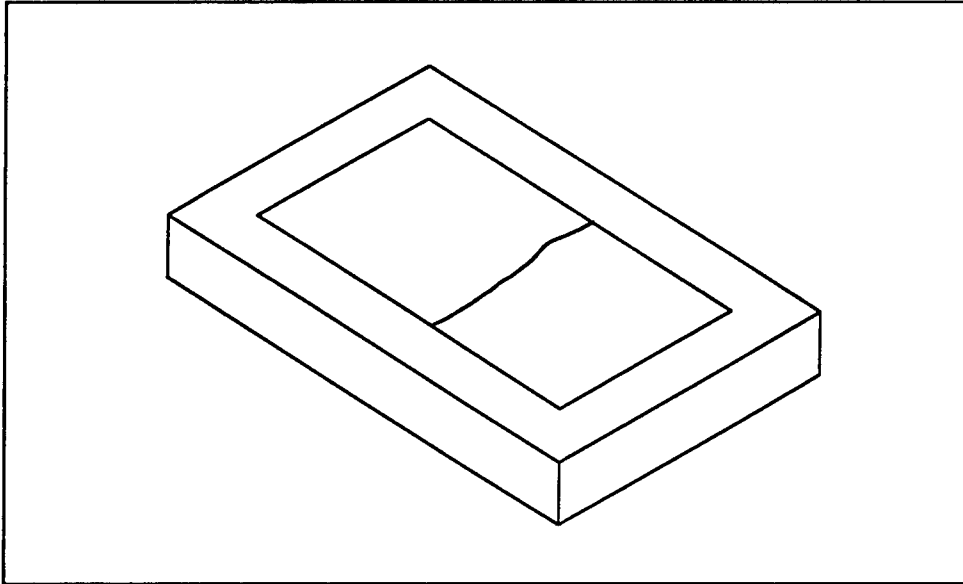
Figure 39. Cracking of Material No. 3B (Arizona)

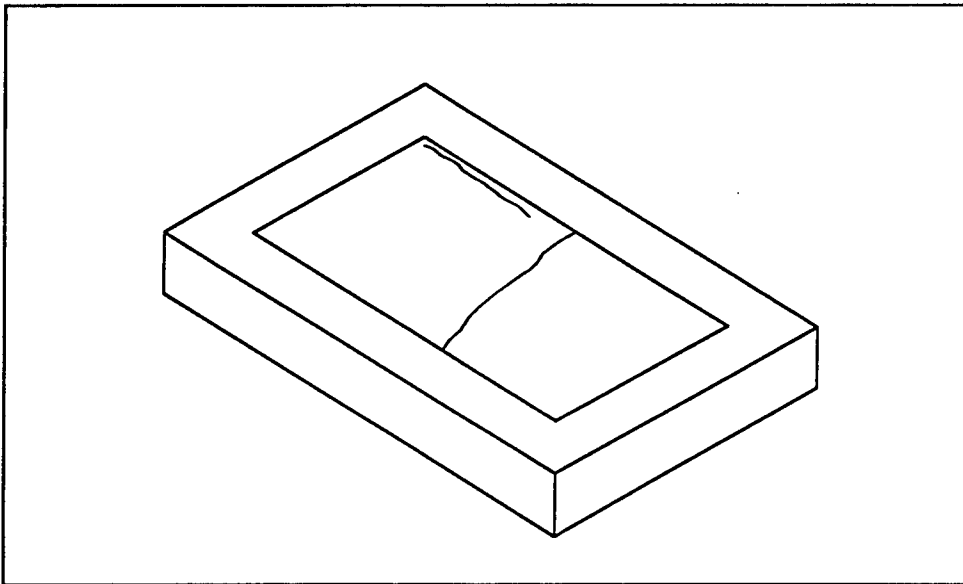
Figure 40. Cracking of Material No. 5B (Arizona)

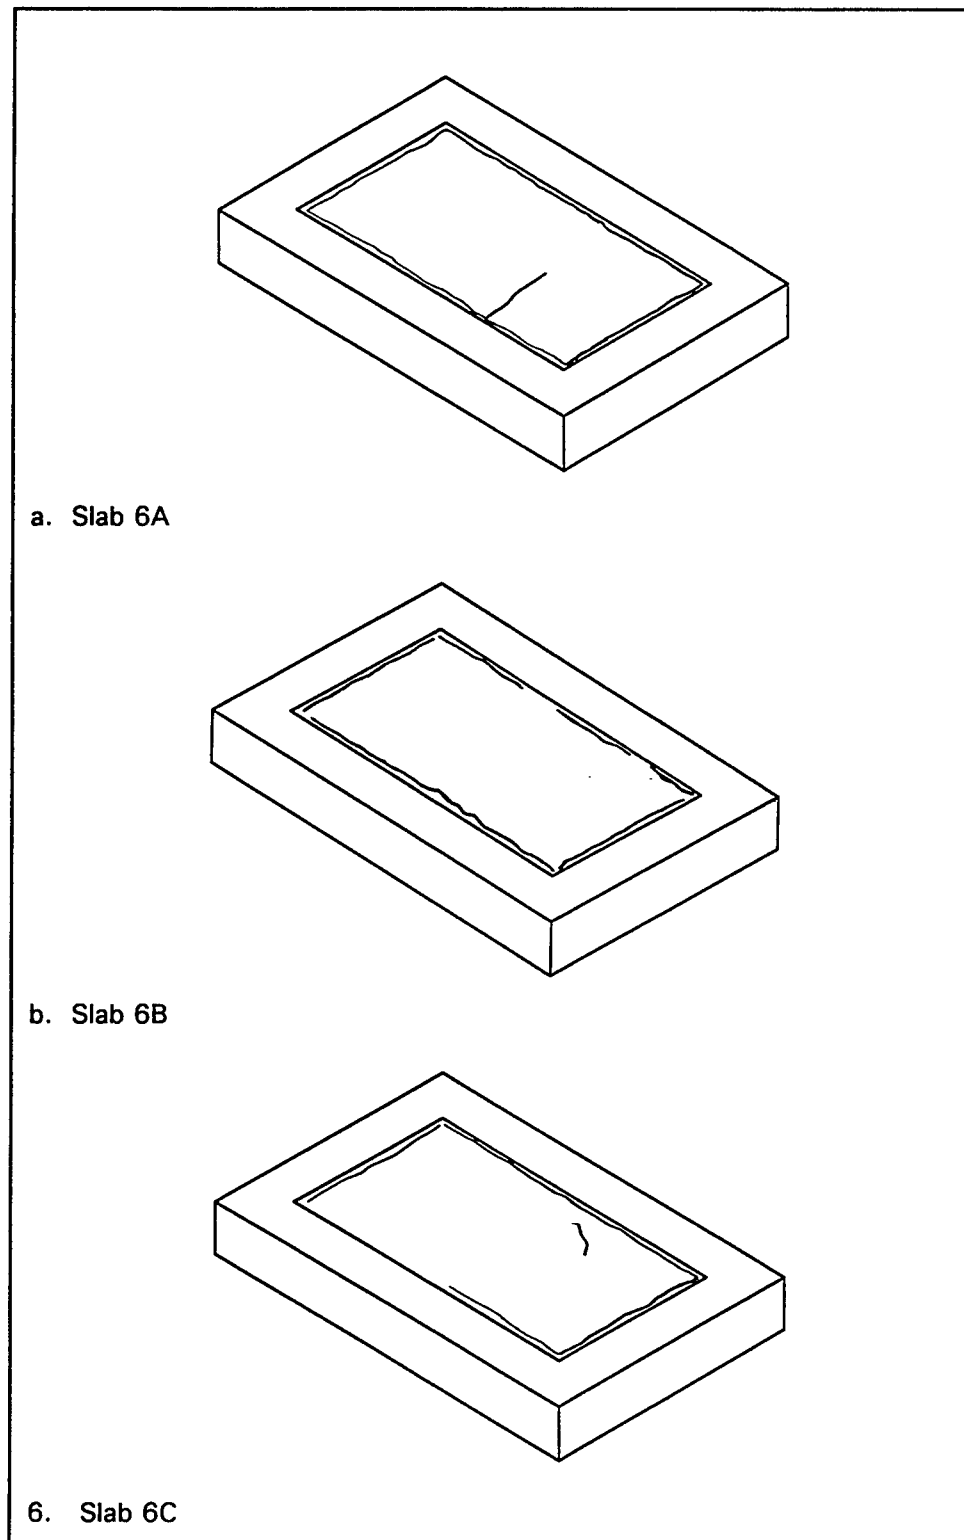
Figure 41. Cracking of Material No. 6 (Arizona)

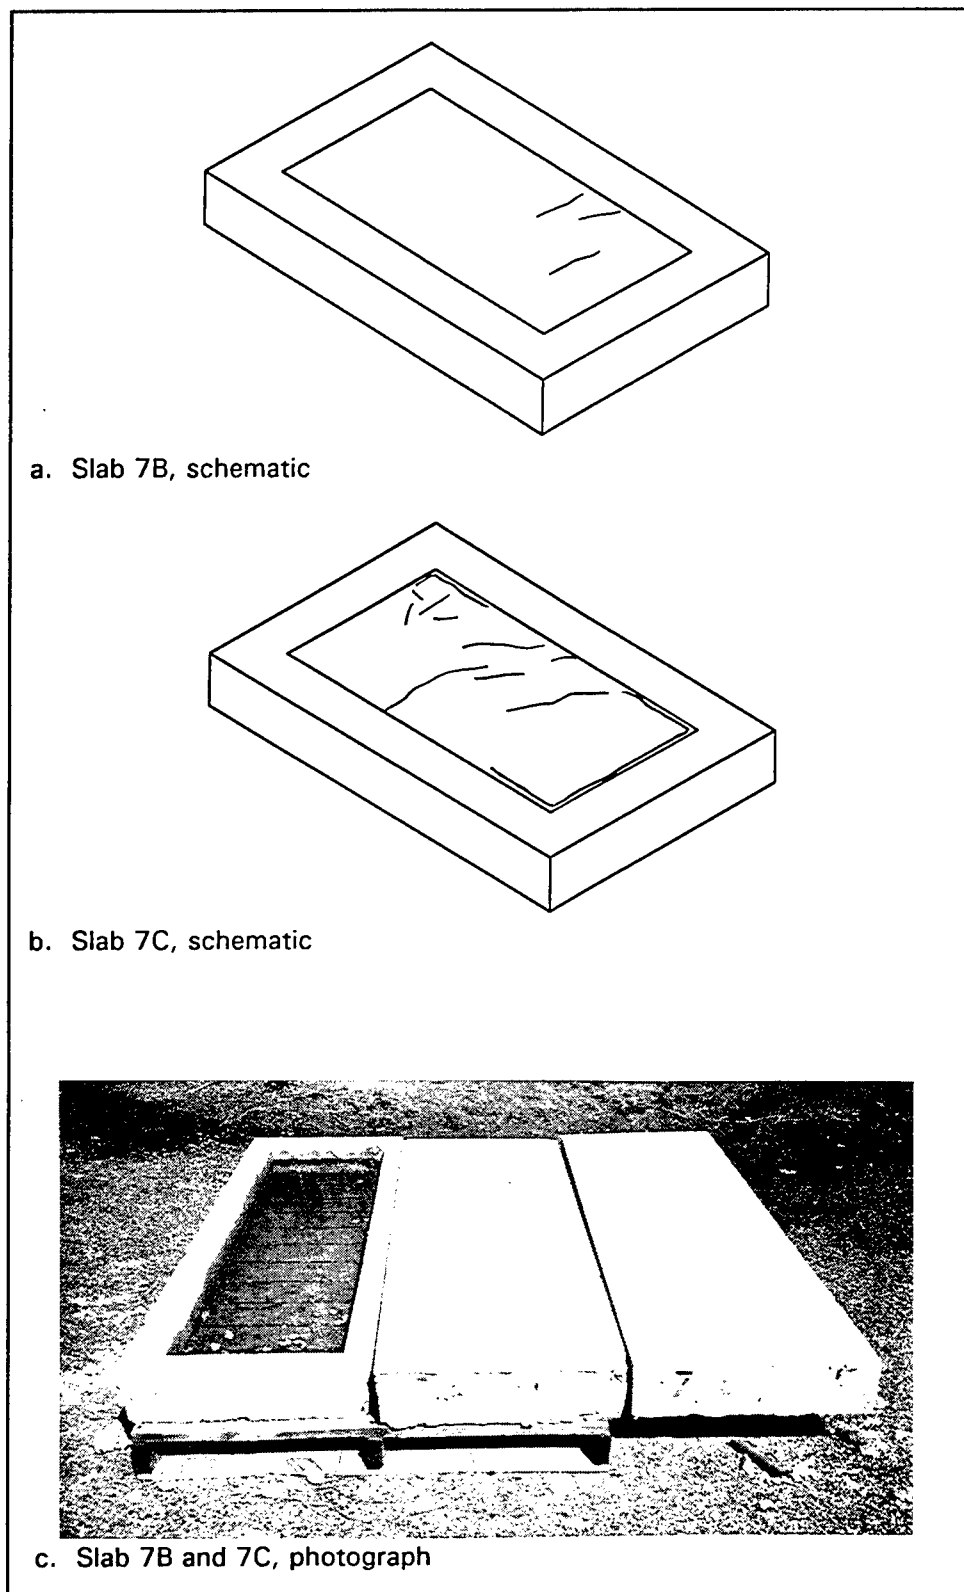
Figure 42. Cracking of Material No. 7 (Arizona)

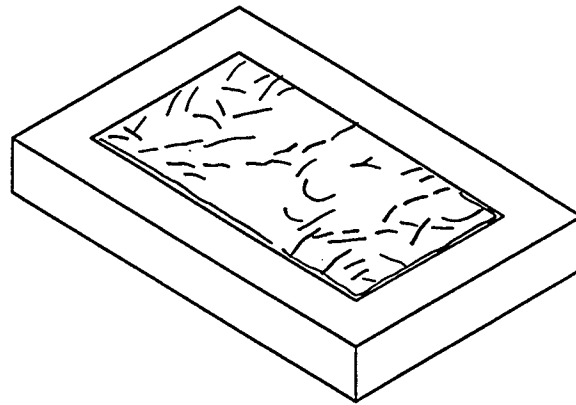
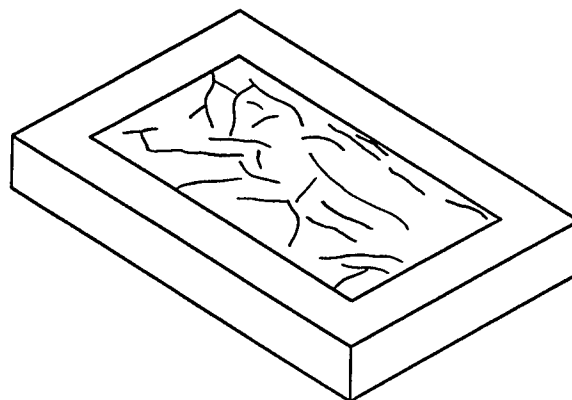
Figure 43. Cracking of Material No. 10 (Arizona)

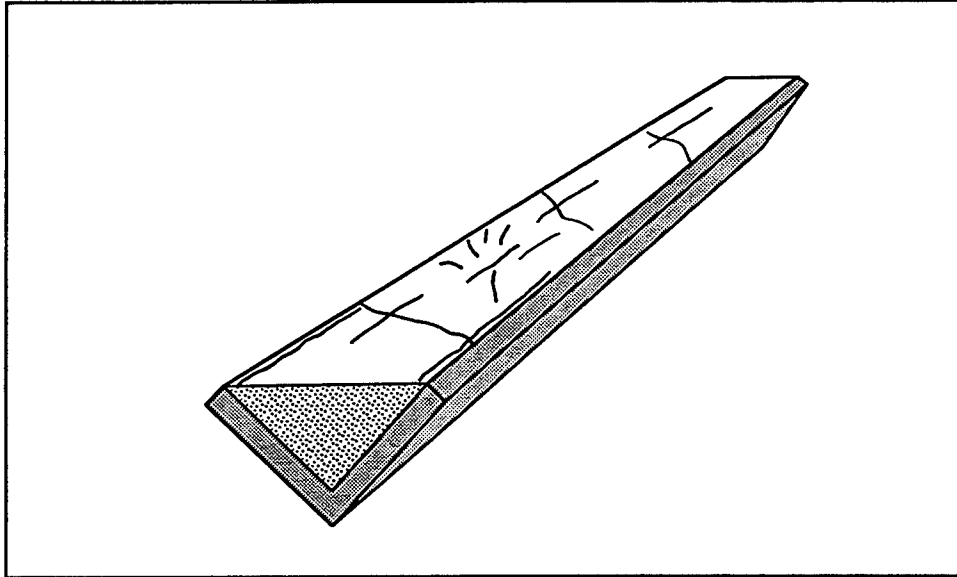
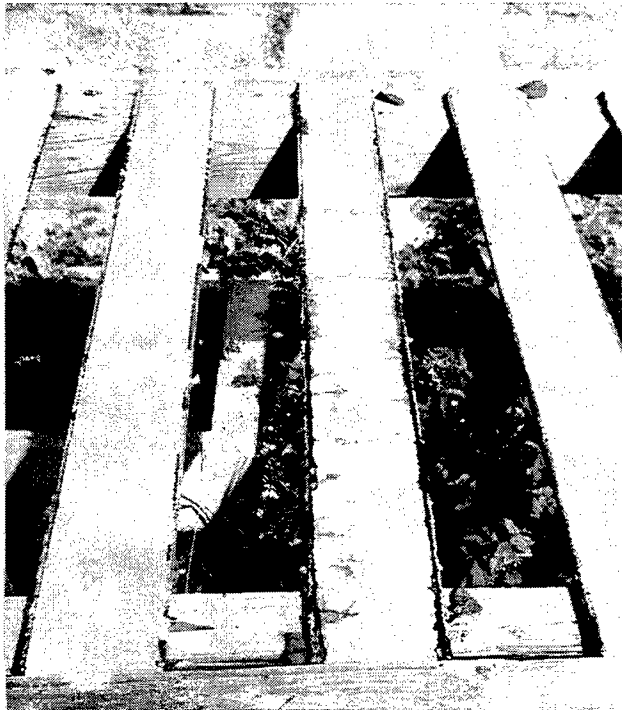
Figure 46. Cracking of Material No. 5 (Florida)

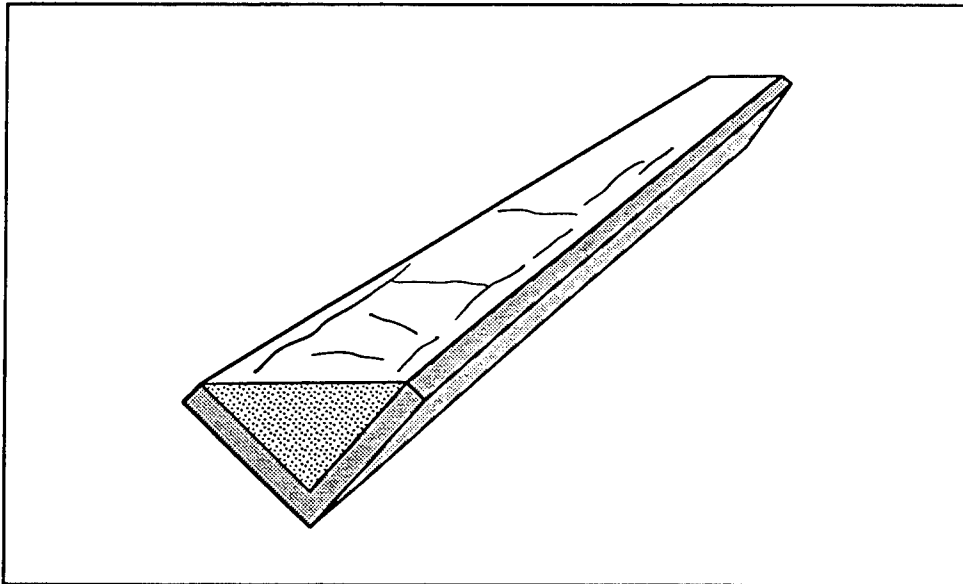
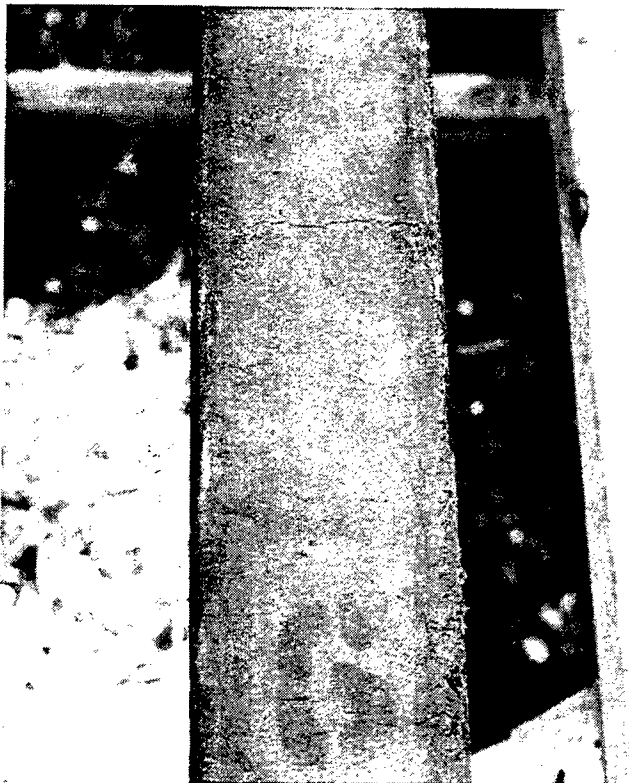
Figure 47. Cracking of Material No. 6 (Florida)

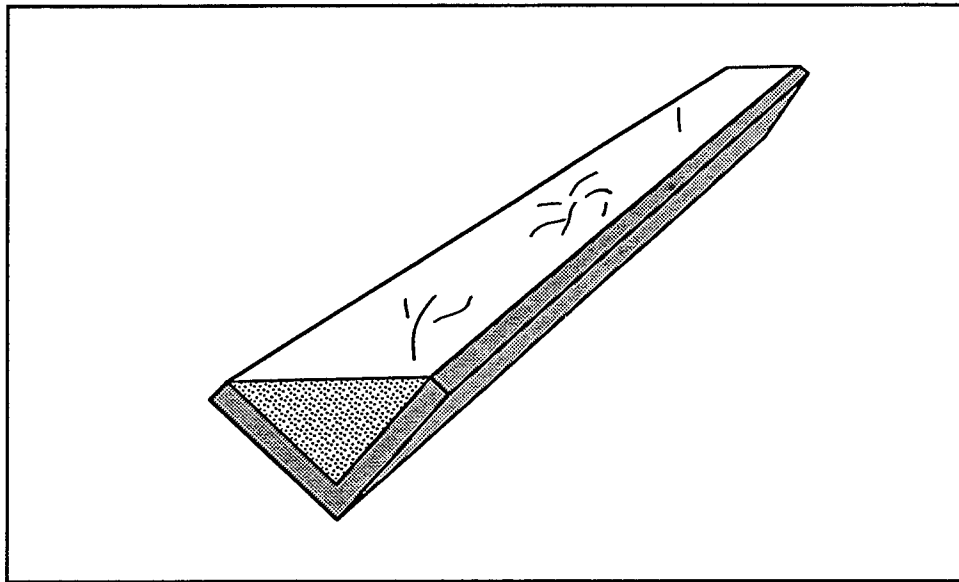
Figure 48. Cracking of Material No. 7 (Florida)

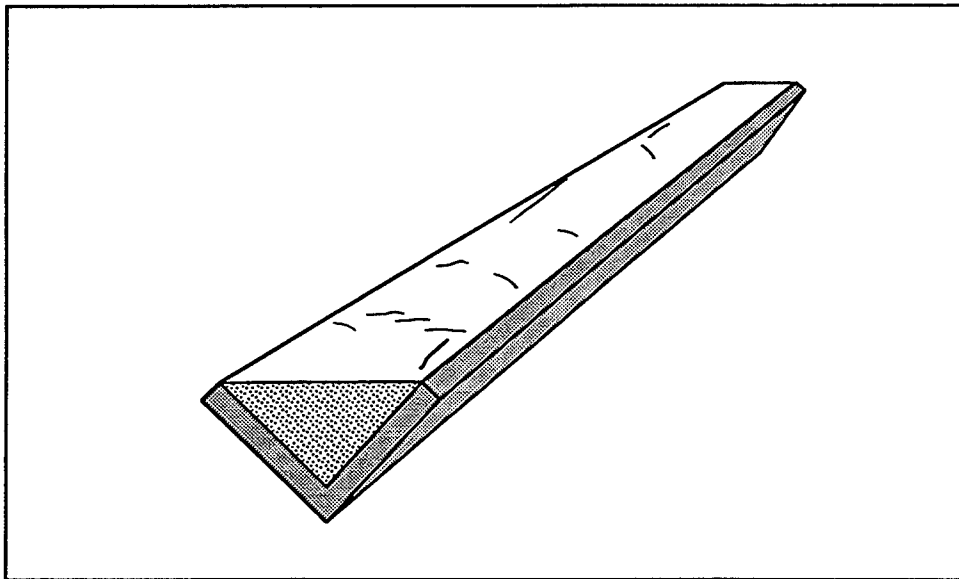
Figure 49. Cracking of Material No. 11 (Florida)

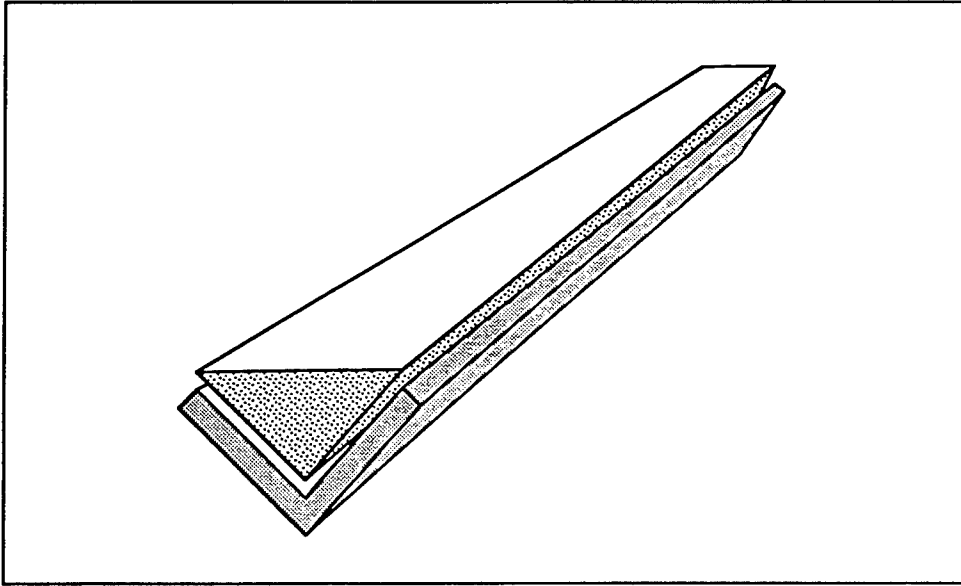
Figure 50. Debonding of Material No. 5 (Illinois)

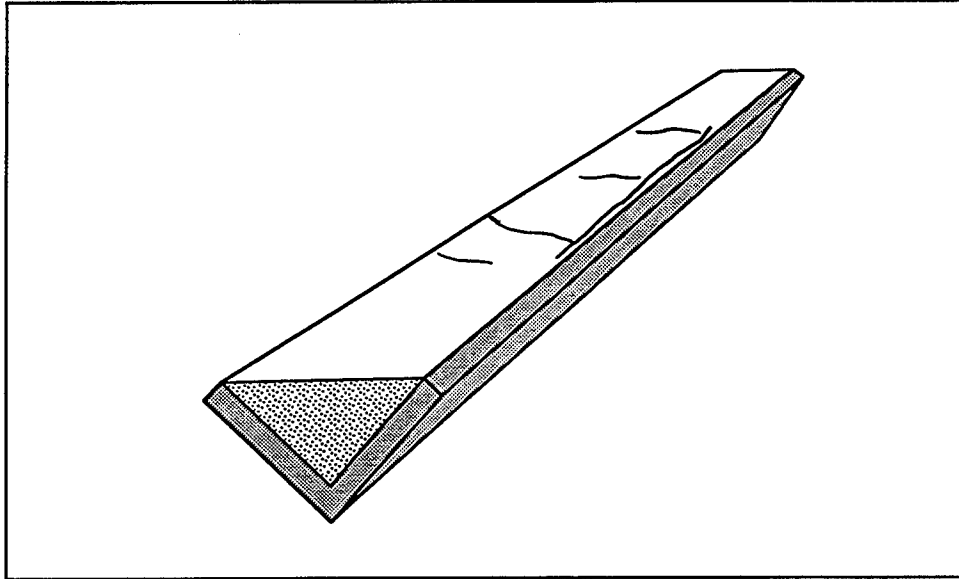
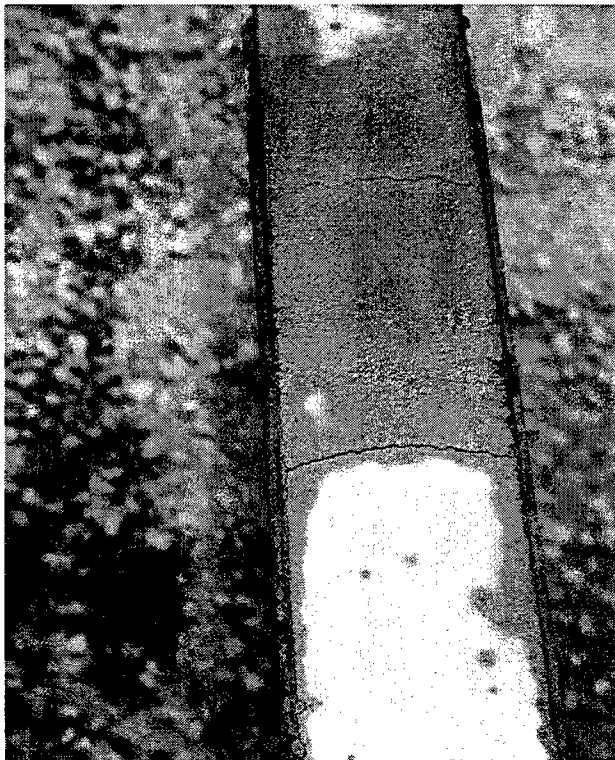
Figure 51. Cracking of Material No. 6 (Illinois)

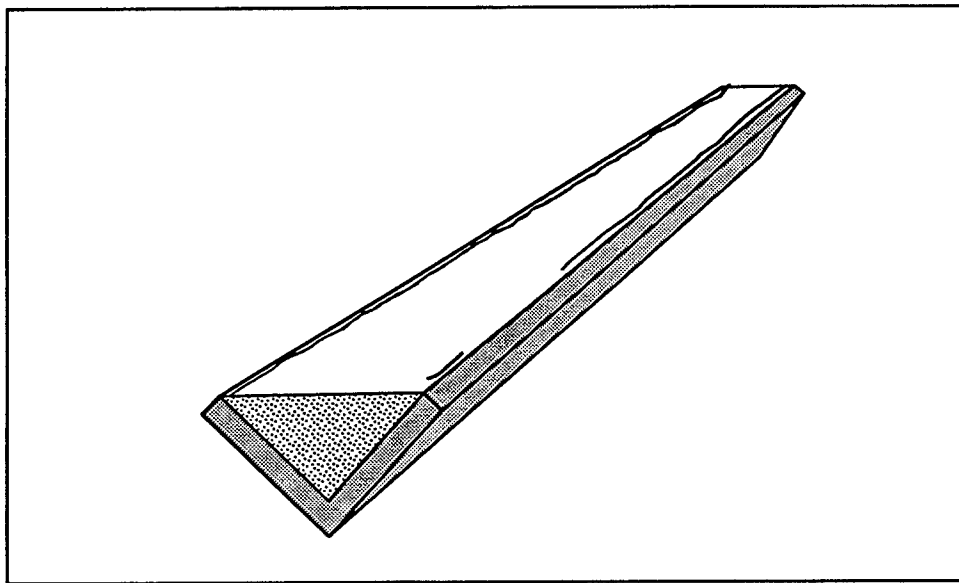
Figure 52. Cracking of Material No. 3 (Arizona)
